## BEFORE AND AFTER IMAGES OF THE 15 ET1 SITES

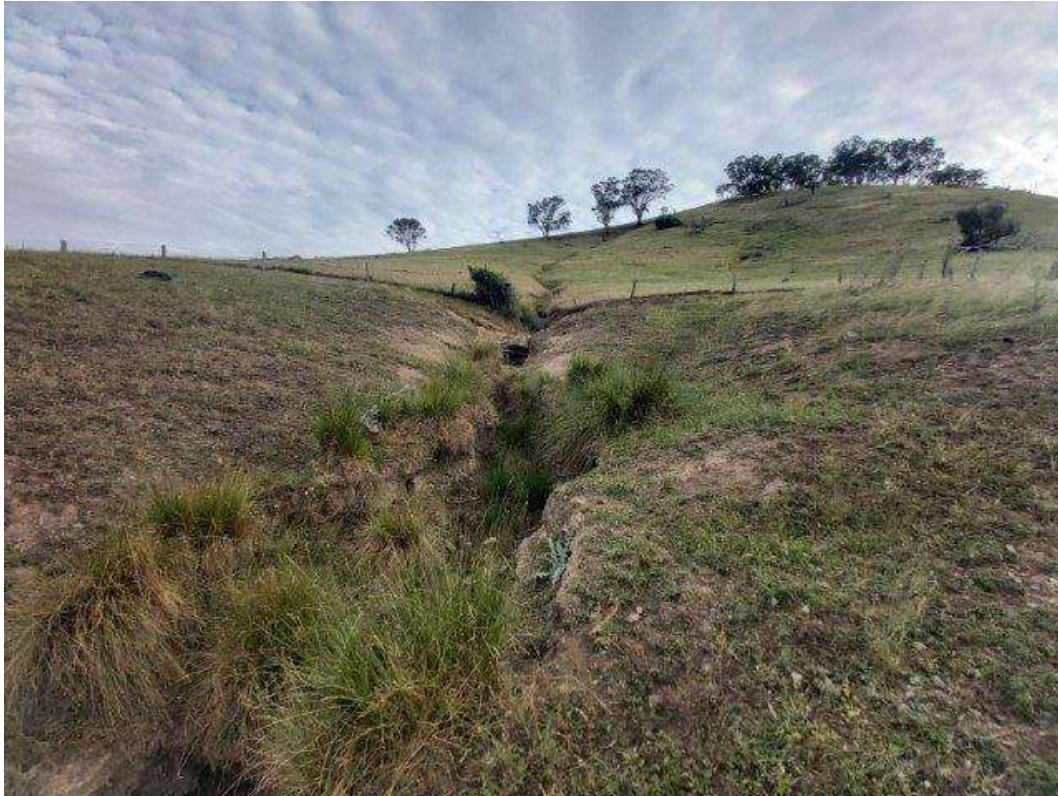
Gully 1 before - water coming down a steep slope from the property uphill has gouged out a gully on Lyn Lea Park

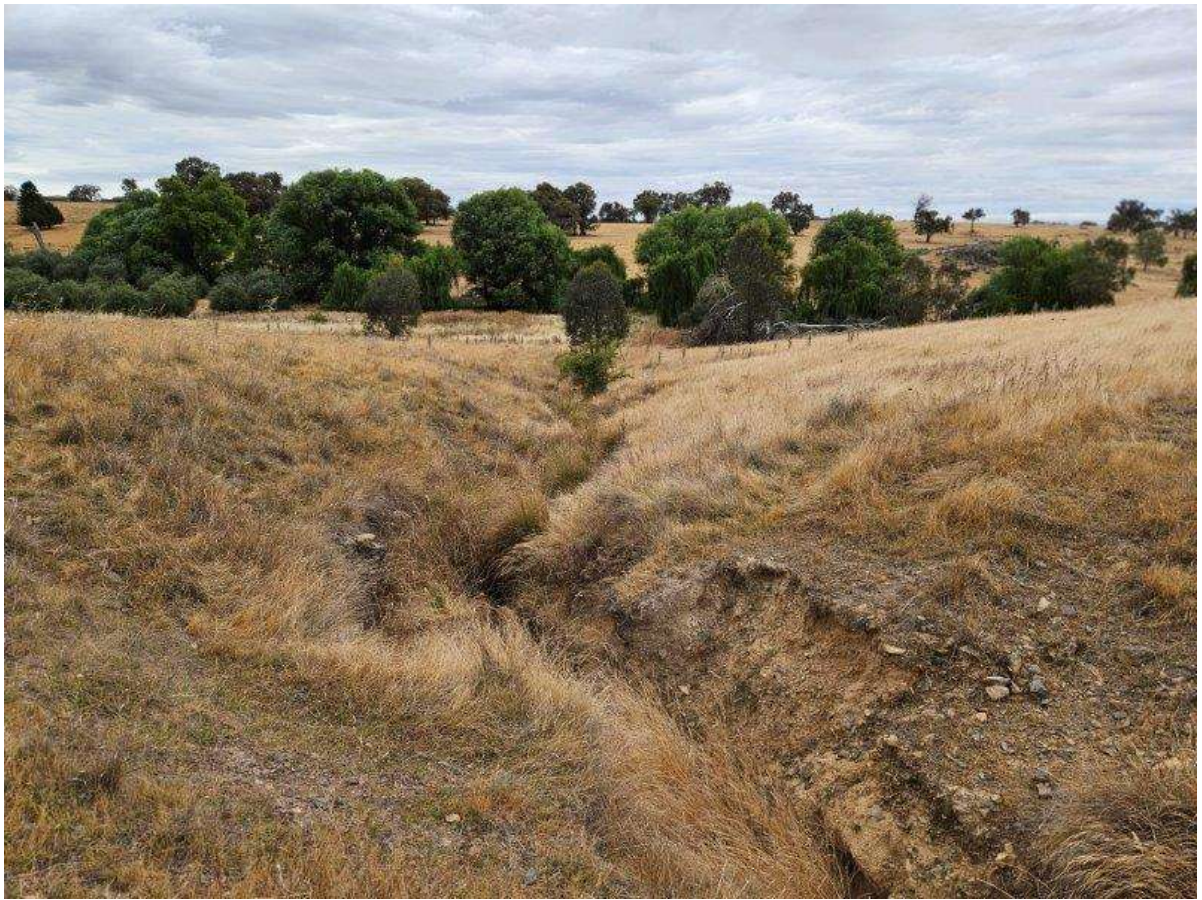
Gully 1 looking downhill, before

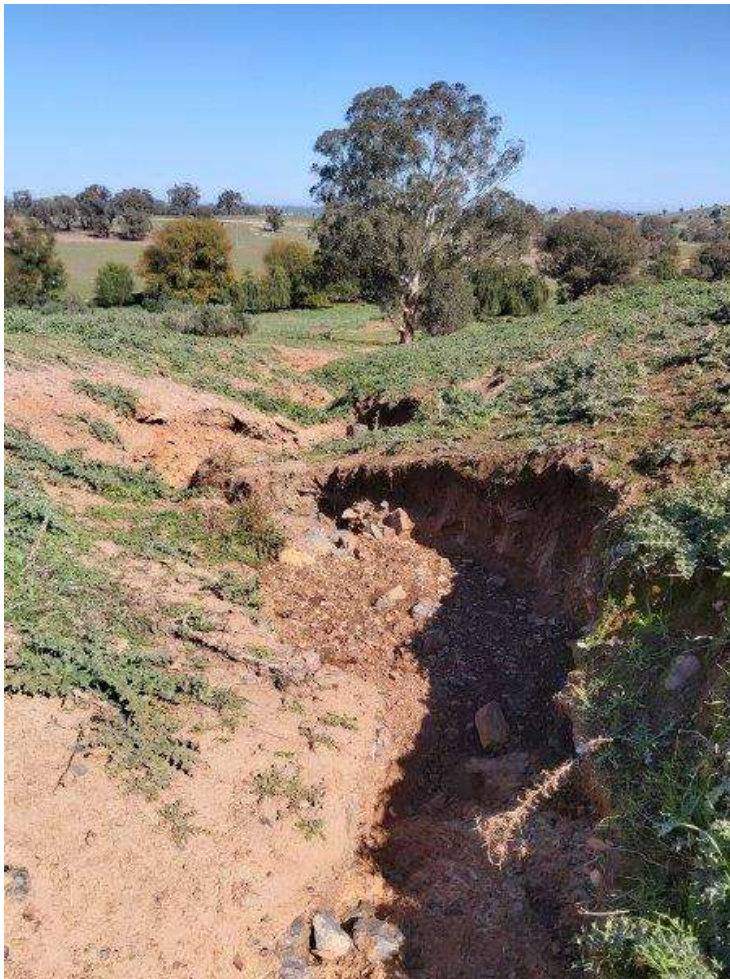
Gully 2 before, looking downhill

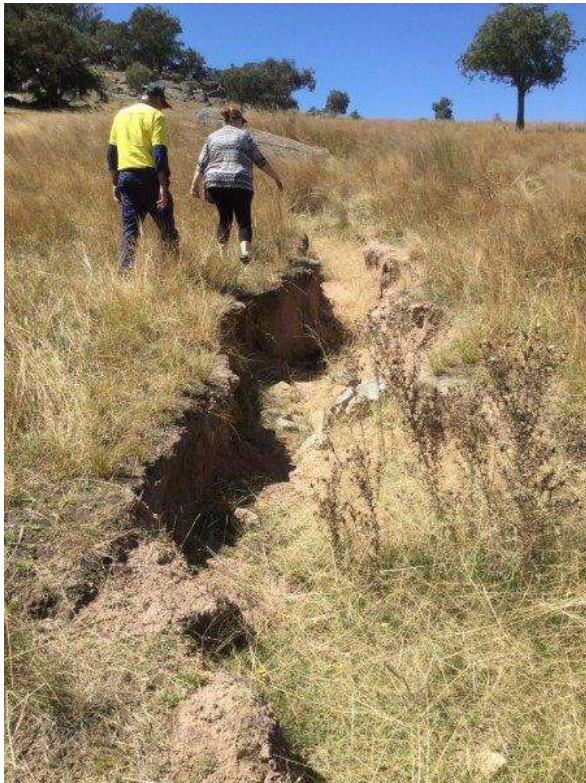
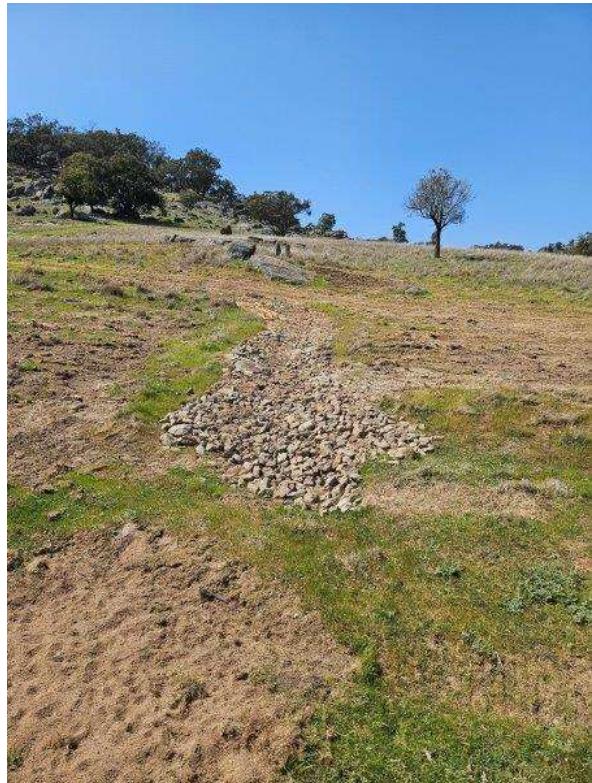
Before and after– above this view, the gully comes from the left, following the contours of the hill

Because it's a relatively shallow gully, and rocks of the right size were readily available from a nearby quarry, the contractor has battered the edges of the gully and filled it with rocks to slow the water flow

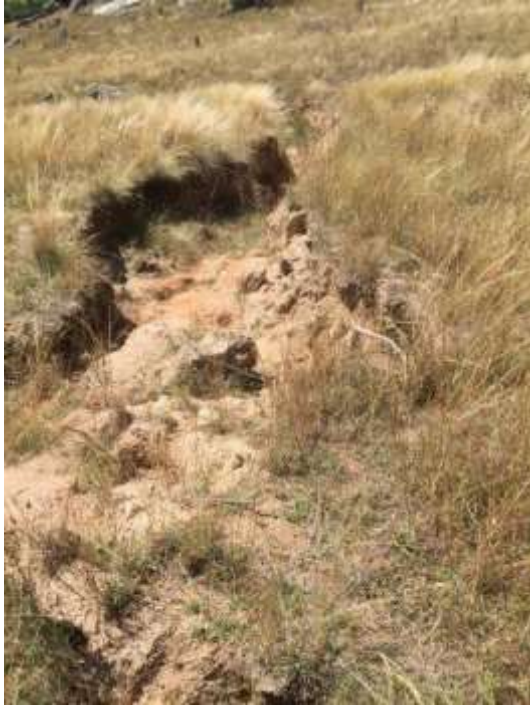
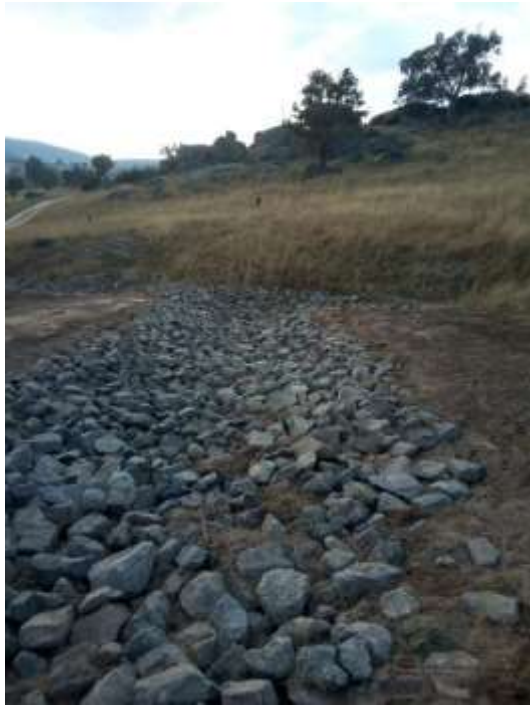
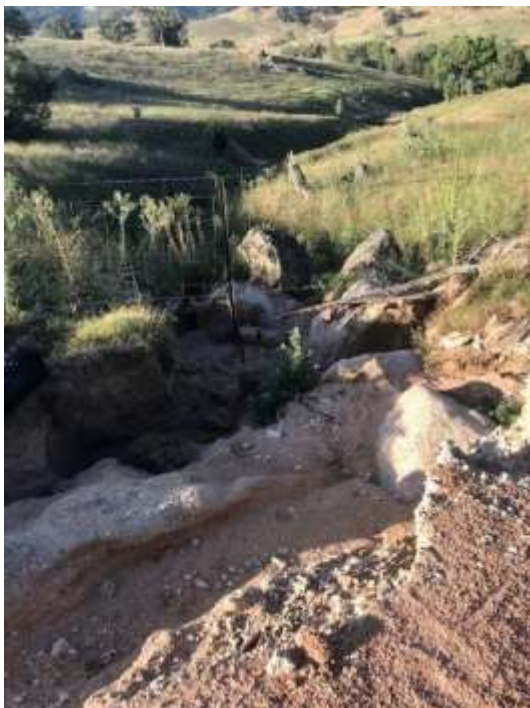
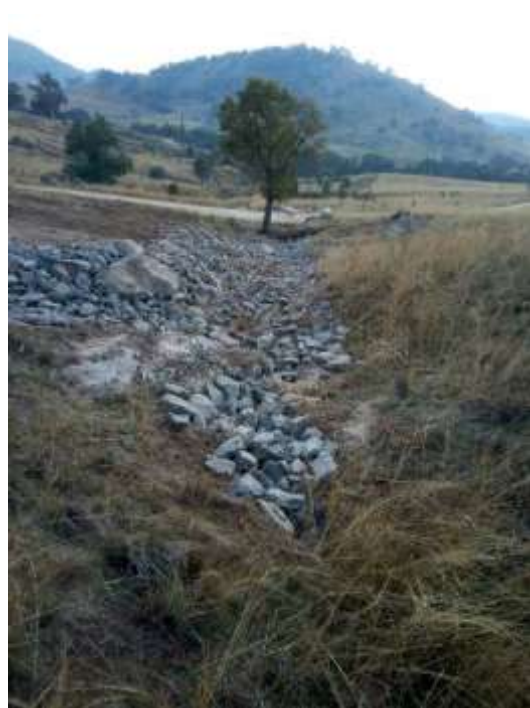
Riverstone site 2

Before and after (2023 and 2024). Top section (first two photos) takes a left turn downhill (second two photos).

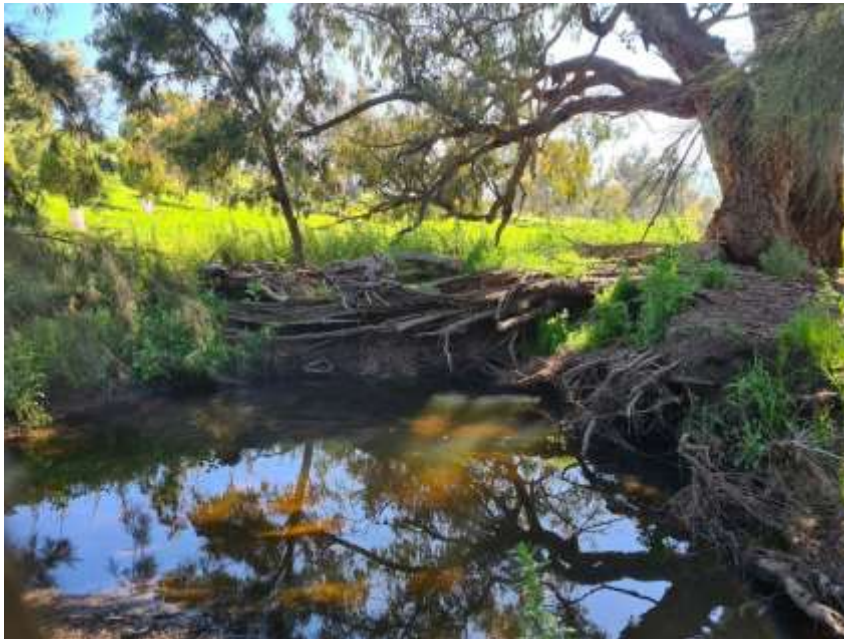
Before - during flooding, the power of the water coming down the creek was scouring the bank and undermining this large old river red gum.

After – the undermined area has been built up and stabilised with a rock groyne, and the bare area seeded. The final image shows the grass stabilising the disturbed area.

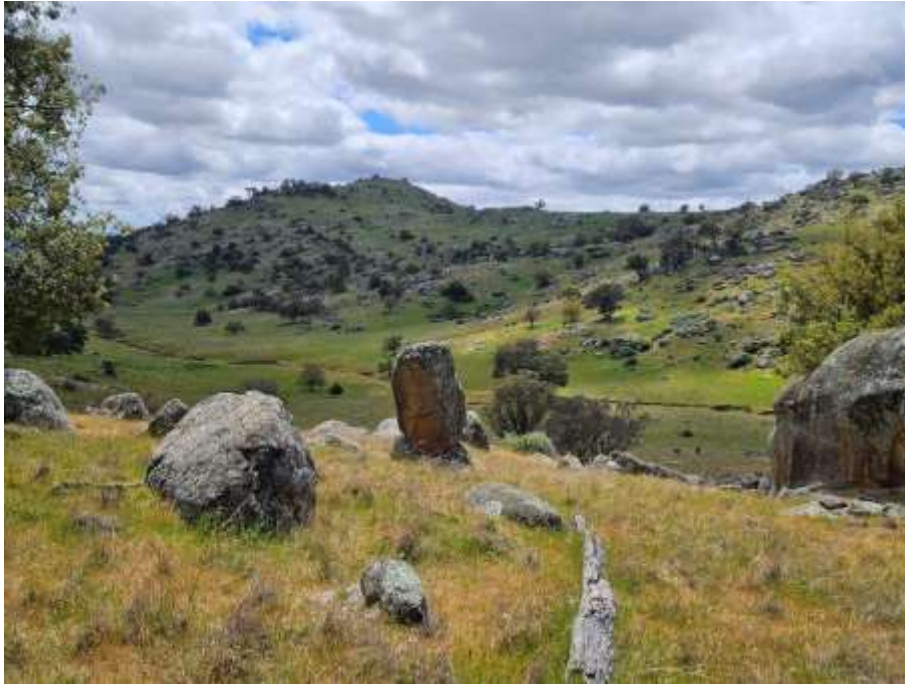
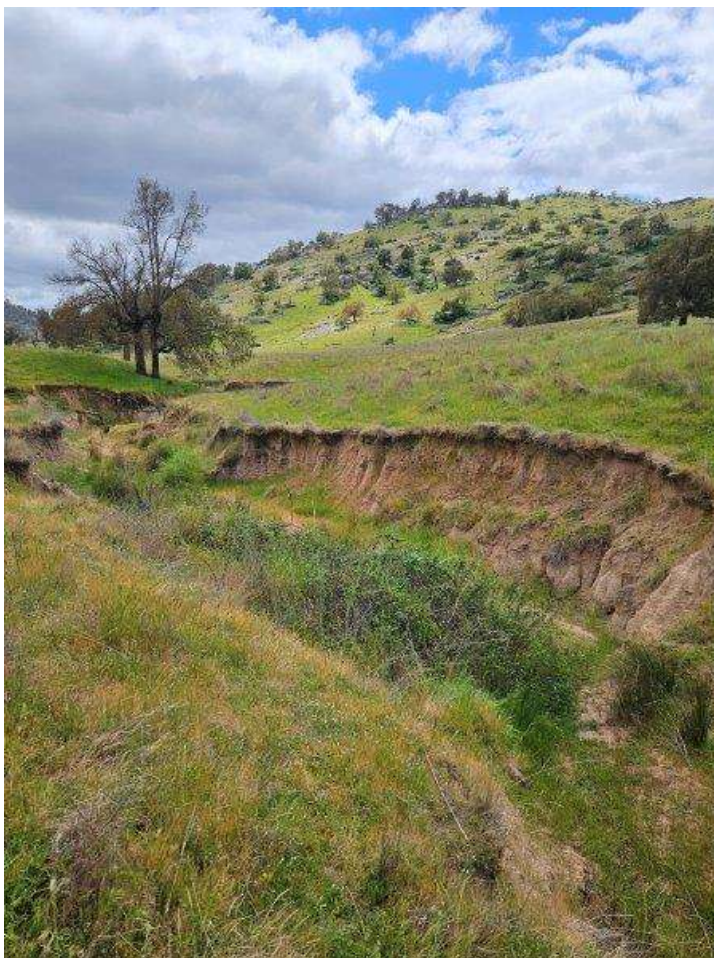
Before (Nov 2023) – overview and close-up of the erosion gully. In the first picture, the gully can be seen as a thin brown line running from right to left at the base of the far slope

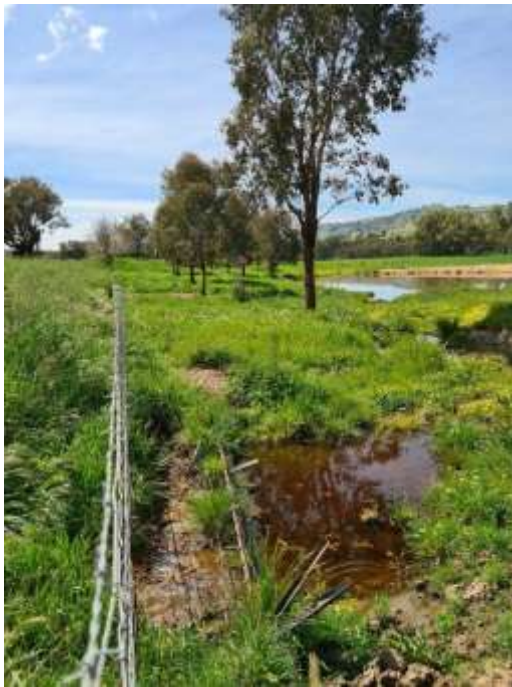
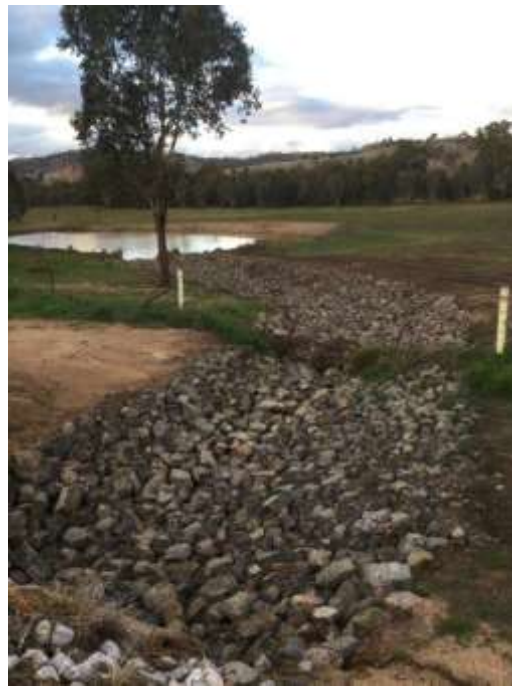
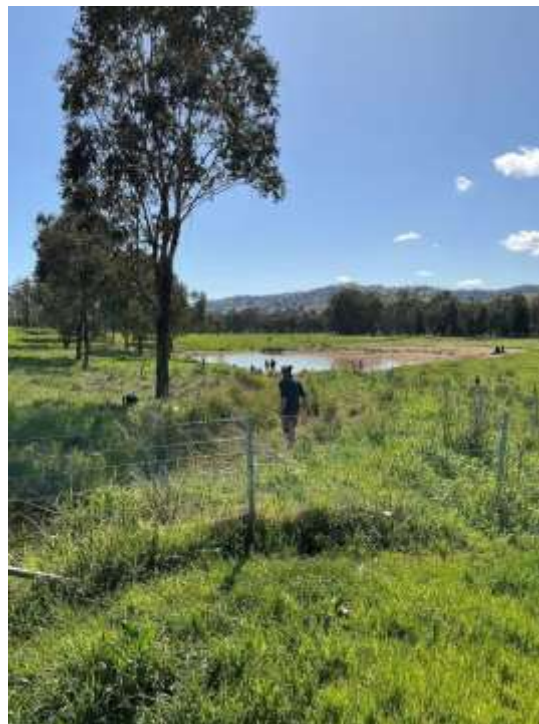
Before and after – water coming through a road culvert at high intensity for decades caused an erosion gully leading to the dam area. The issue was resolved by shaping the area, putting geotech fabric down and covering it with a rock-lined channel. The next pictures show planting and fencing from stock, and the strong growth of the stabilising vegetation over the next three years, to the point where the rock-lined channel can't be seen any more.

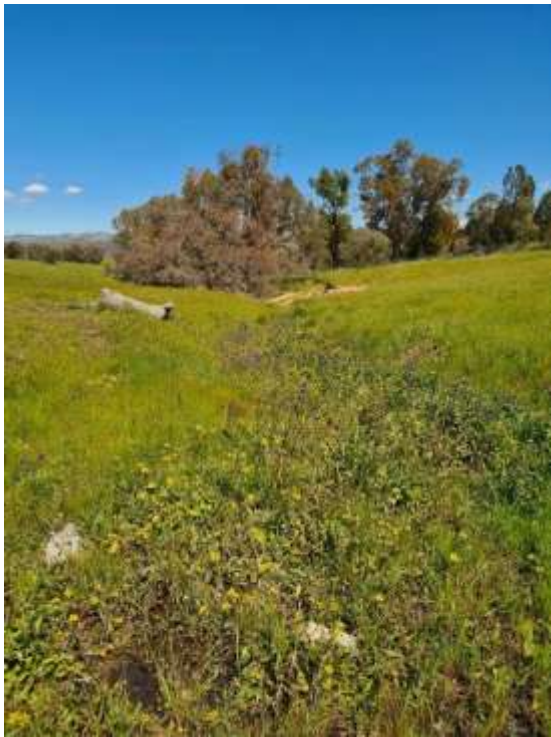
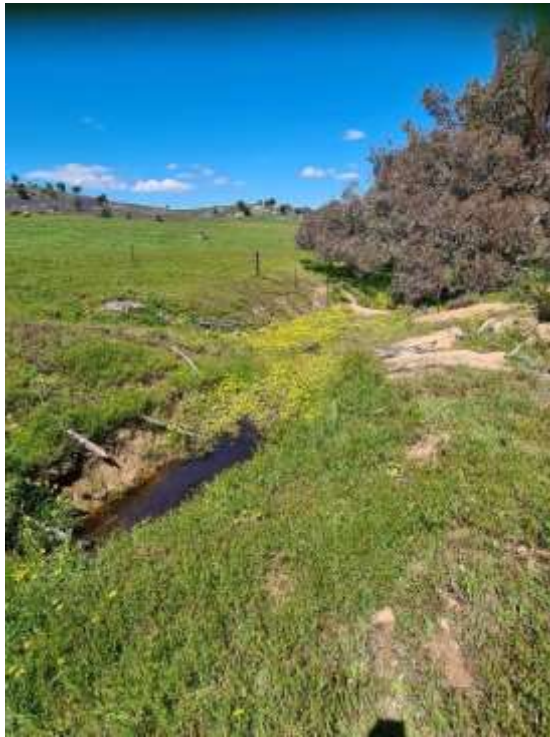
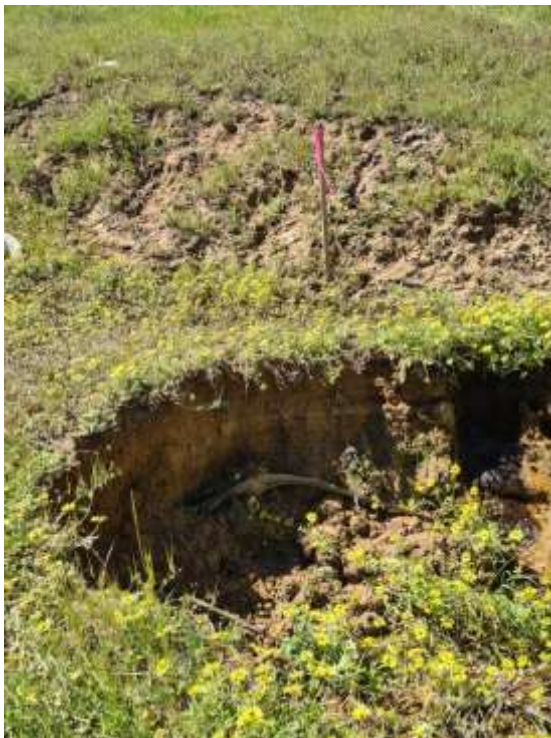
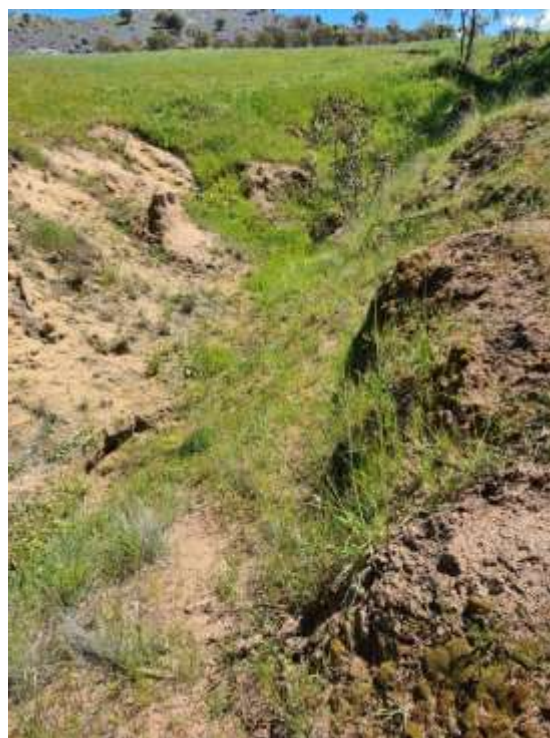
Before – (2021 after a year of rain. Normally bare and scoured). Long view and close-ups. Concentrated flow from a road culvert uphill has created this erosion gully that plunges steeply downhill in front of the eucalypt. Although normally scoured bare, the vegetation is thick here due to two rainy years

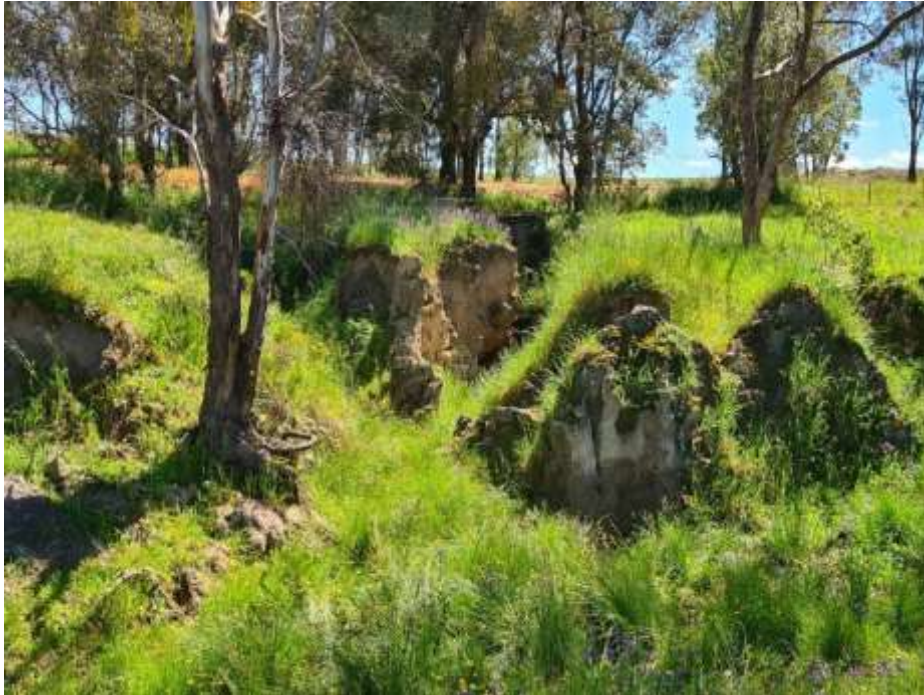
Before (2021) - This deeply gouged, very long gully is the result of decades of concentrated flow from a road culvert on the steep road above, with no structures put in place to slow the speed of the water entering the property. The culvert can be seen in the top middle of the picture just below the road.

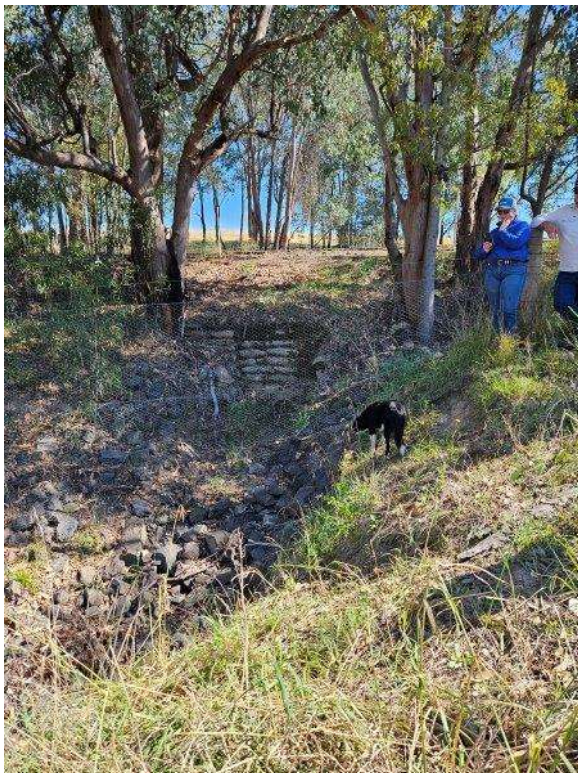
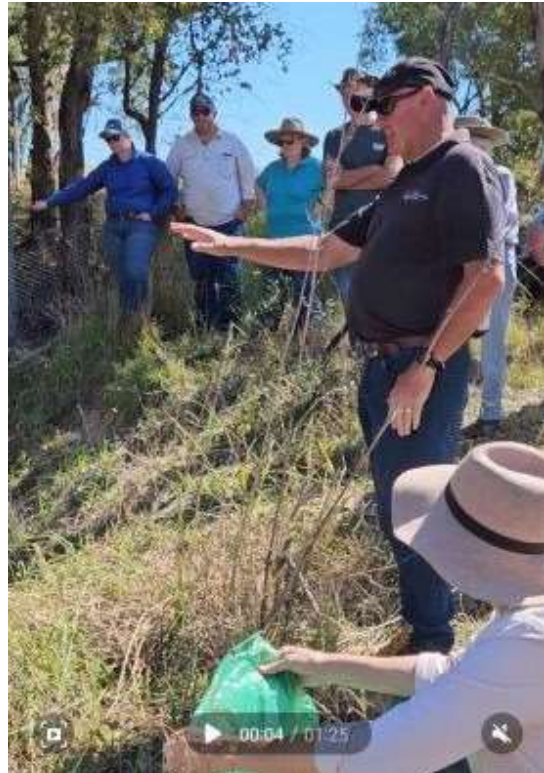
April 2024 at the ET1 erosion control field day. The area has largely stabilised

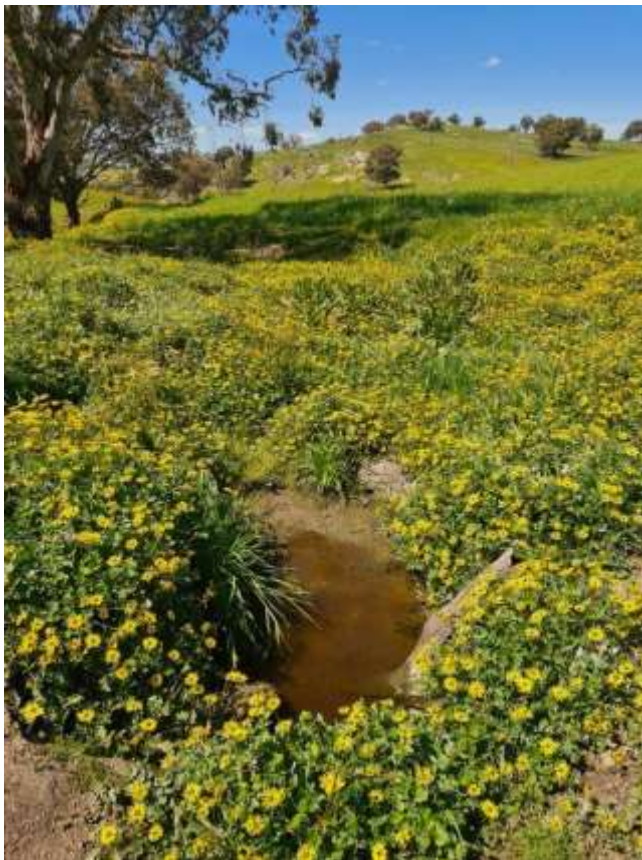
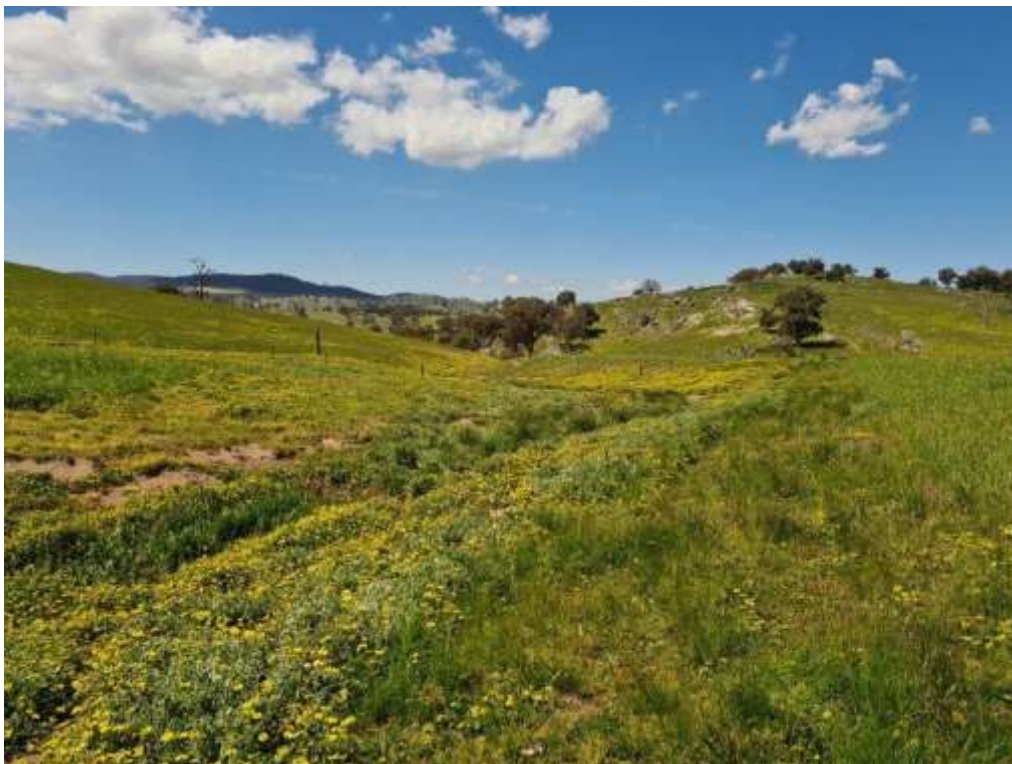
Willow Glen site 1

Before (2020) - actively eroding head and gully

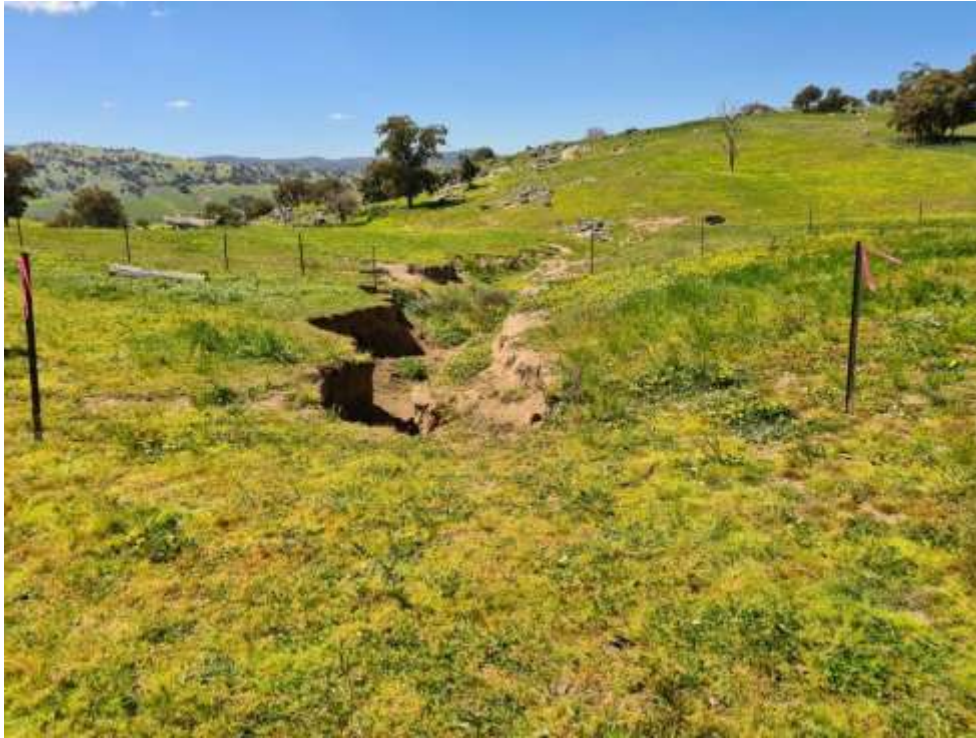
Willow Glen site 2

Before (2020) Actively eroding head and gully heading downhill

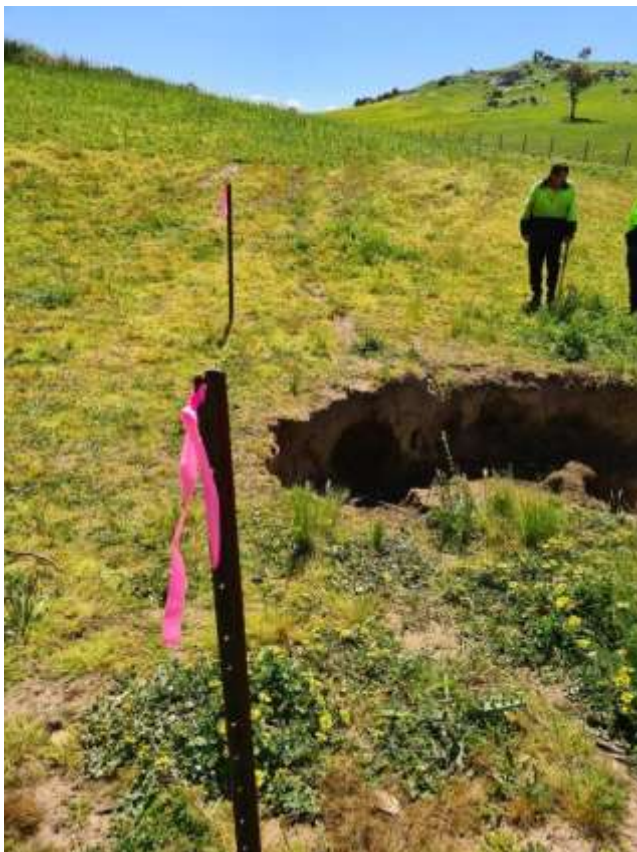
Close-up of actively eroding head (taken at right angles to previous photo). Both these photo points ended up under water.

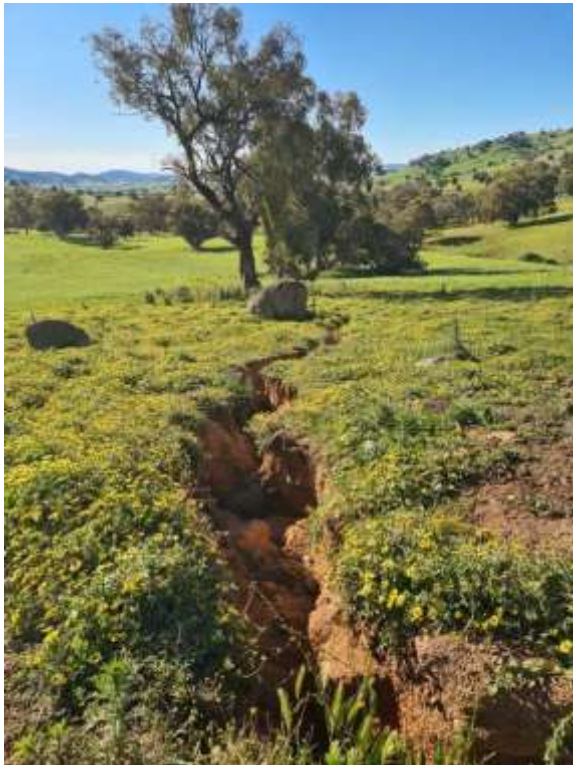
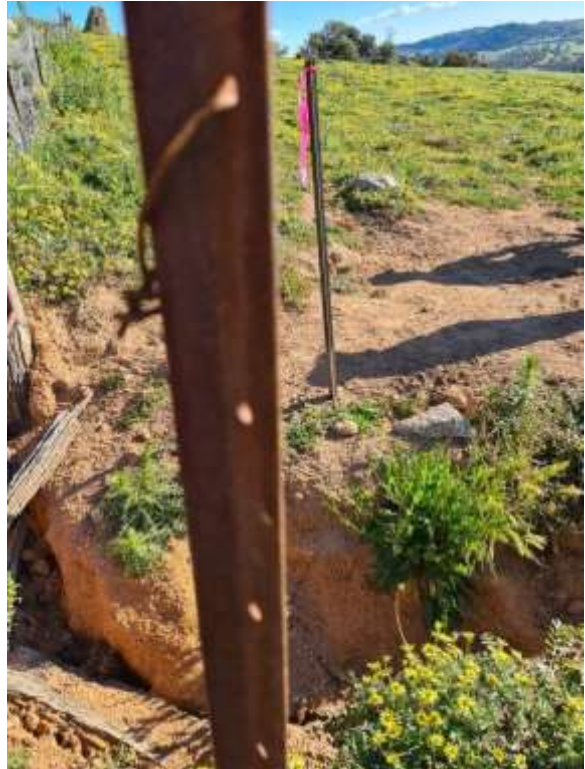
Site 1 before (2020) Gully looking downhill and looking across the top of the gully

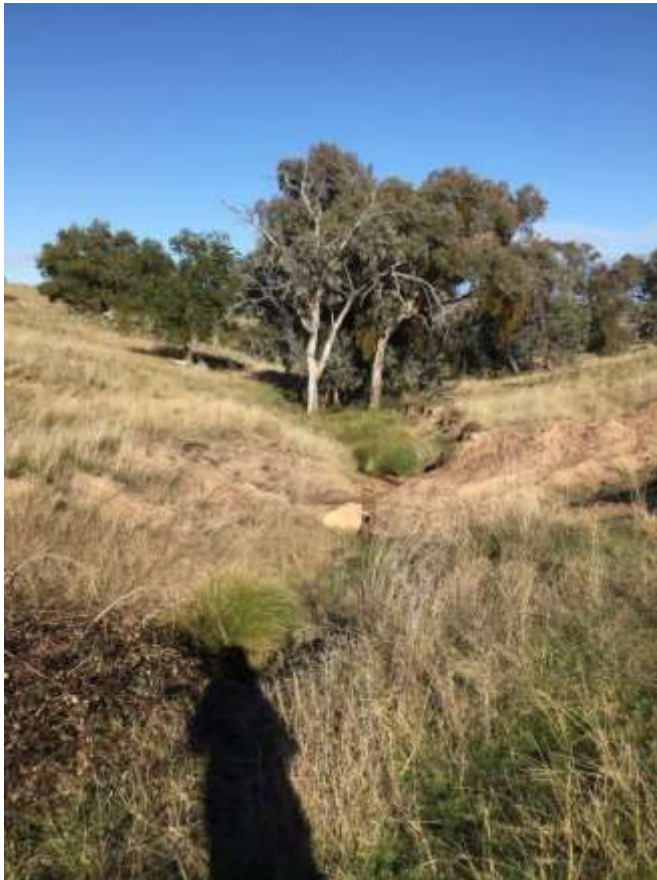
Before (2020) Looking down the gully

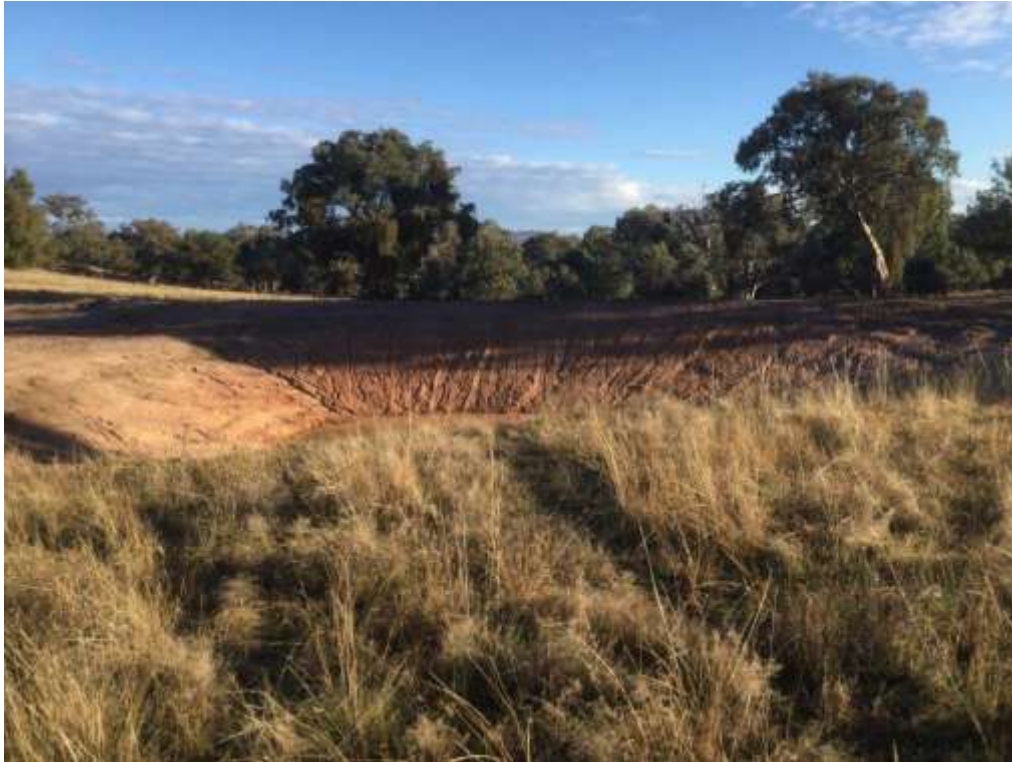
After (2021) The original site 4 was rejected by Soil Conservation Service as having inappropriate soils. This site was selected instead and the dam built before the project manager could get there to take a before photo.

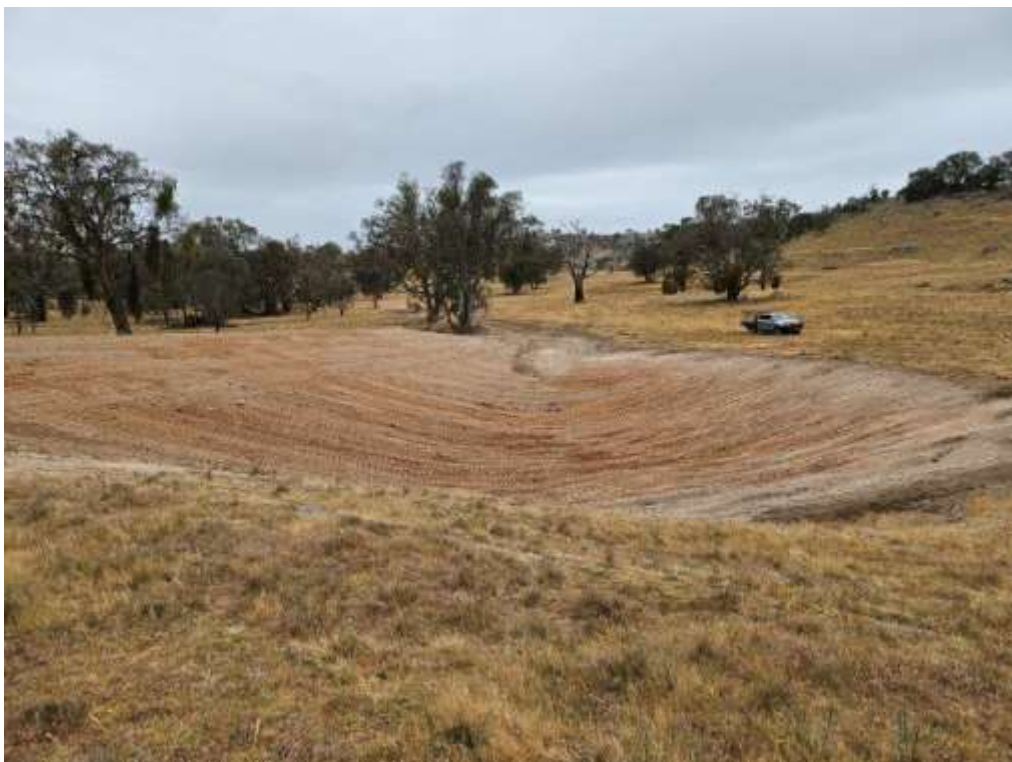
2023 after largely unsuccessful maintenance work to allow this dam to hold water. This dam now operates as a leaky dam ie still slows water but doesn't hold it permanently.

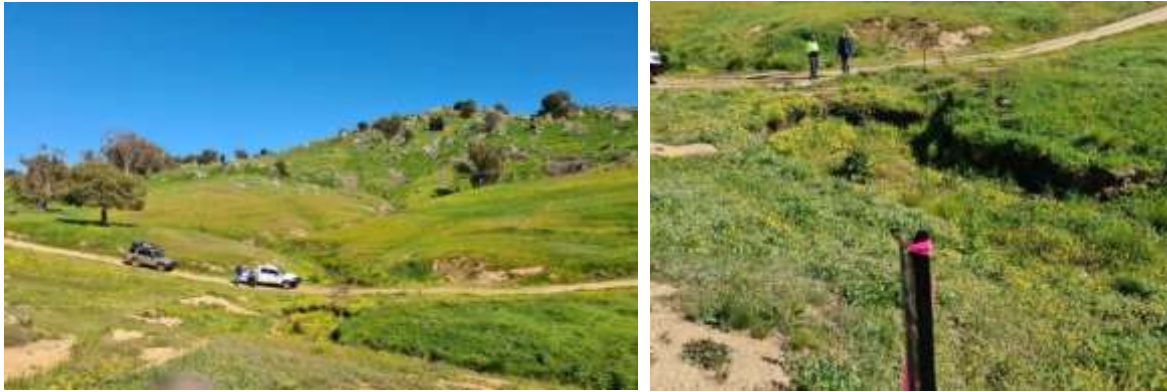
Before (2020) – water from the steep hill was cutting a deep gully downhill of the road and a section of bank was slumping.

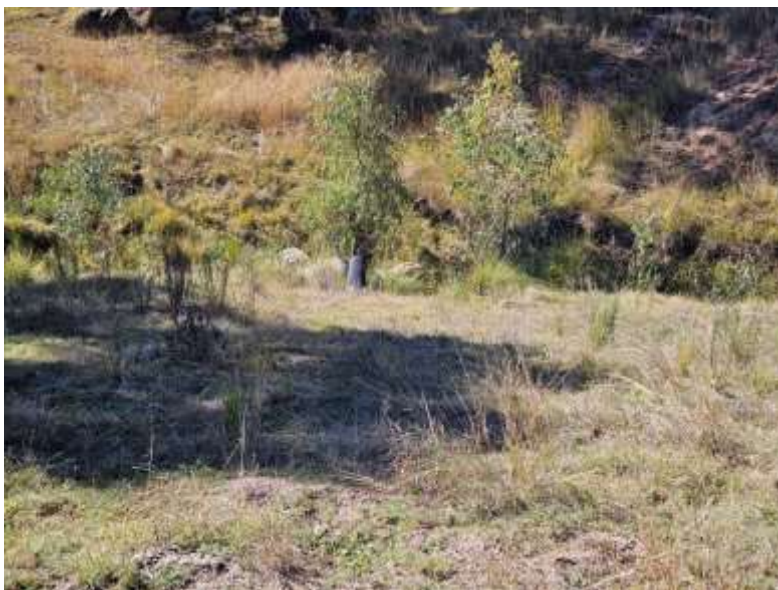
Gully showing trickle pipe emerging and a mix of plantings and self-seeded plants.
