## BEFORE AND AFTER IMAGES OF THE 15 ET1 SITES

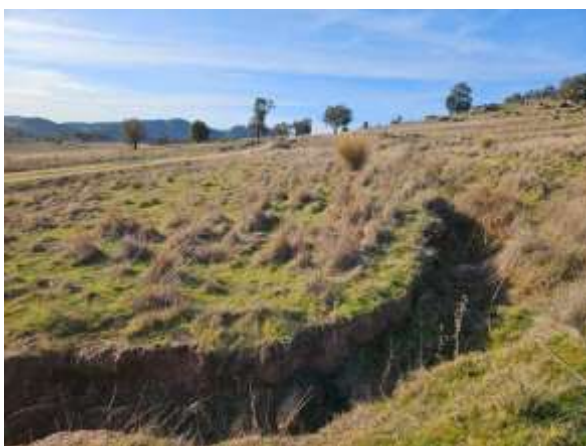
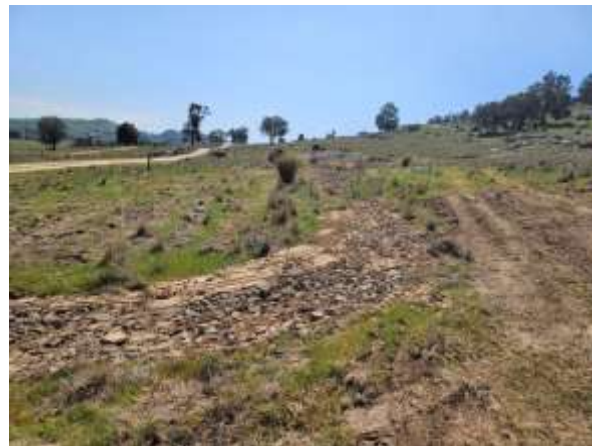
Before and after– above this view, the gully comes from the left, following the contours of the hill

Because it's a relatively shallow gully, and rocks of the right size were readily available from a nearby quarry, the contractor has battered the edges of the gully and filled it with rocks to slow the water flow

This angle shows the gully before and after as it comes from the left

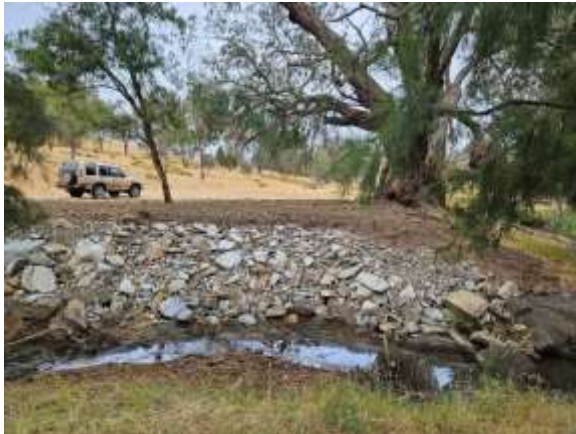
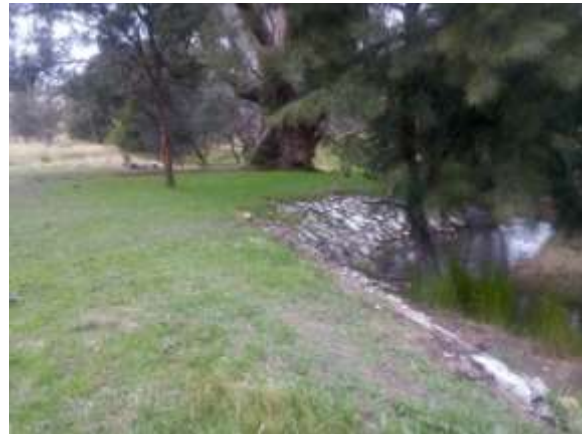
Before - during flooding, the power of the water coming down the creek was scouring the bank and undermining this large old river red gum.

After – the undermined area has been built up and stabilised with a rock groyne, and the bare area seeded. The final image shows the grass stabilising the disturbed area.

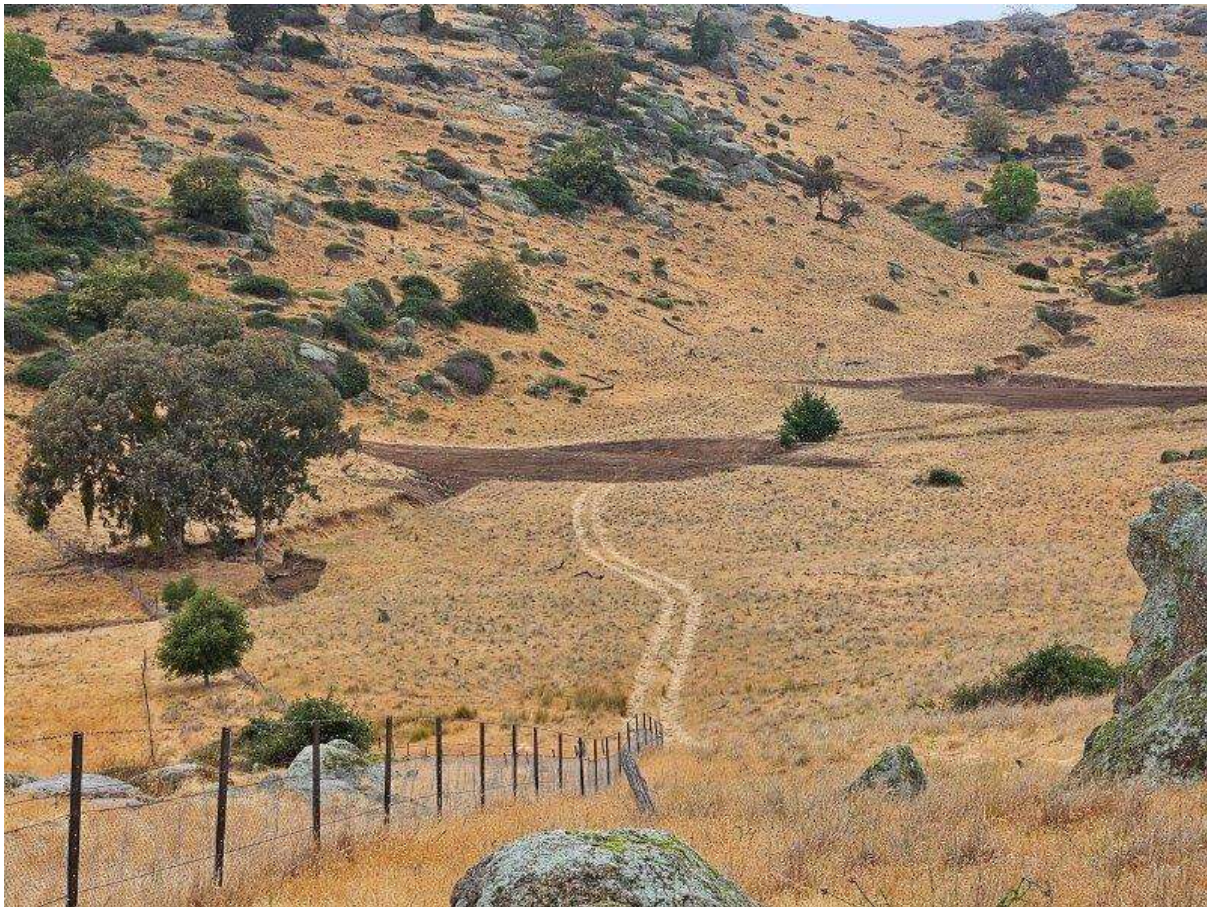
Different perspective, looking up the valley Nov 2023

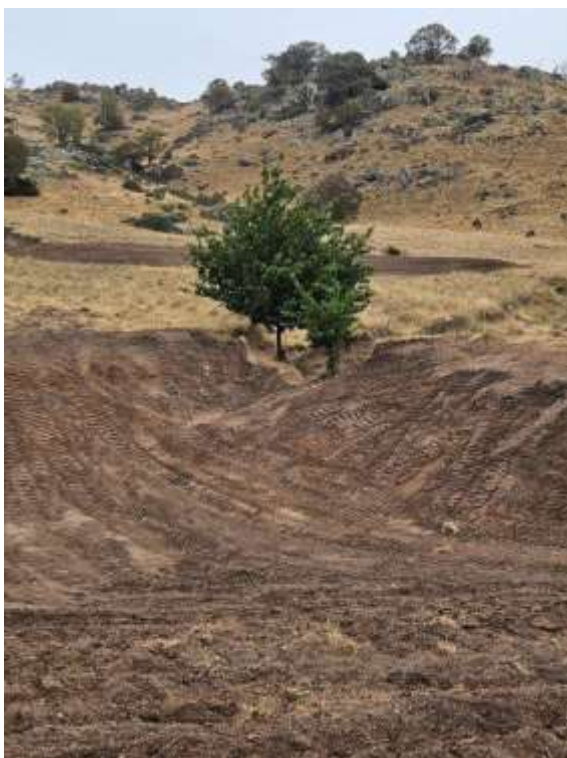
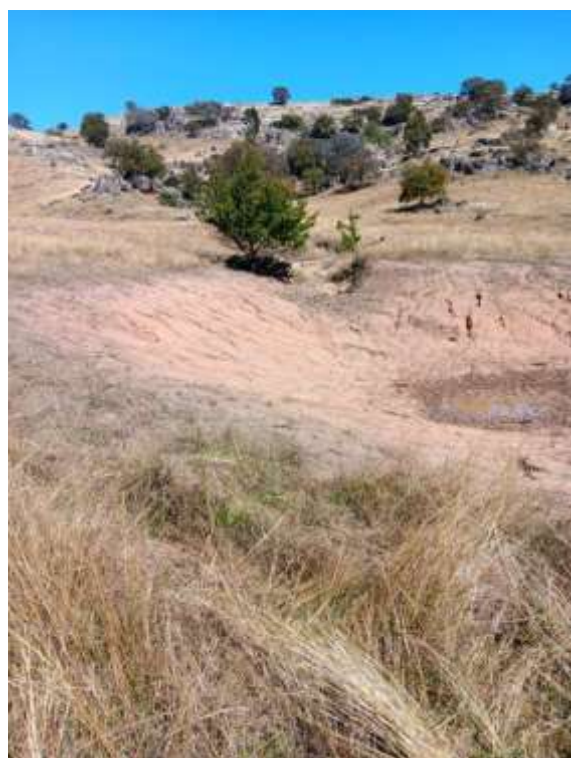
Immediately after works (Nov 2023)

and April 2024

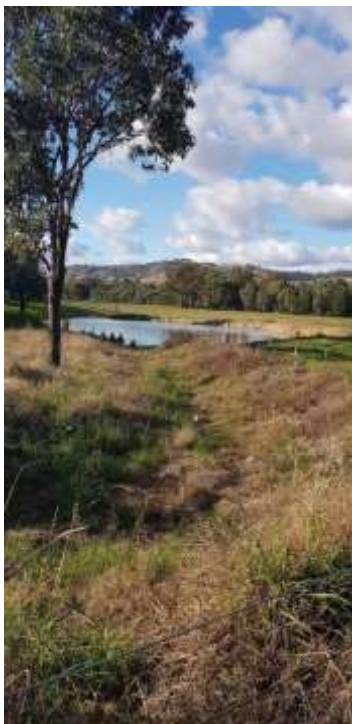
2022

Before and after – water coming through a road culvert at high intensity for decades caused an erosion gully leading to the dam area. The issue was resolved by shaping the area, putting geotech fabric down and covering it with a rock-lined channel. The next pictures show planting and fencing from stock, and the strong growth of the stabilising vegetation over the next three years, to the point where the rock-lined channel can't be seen any more.

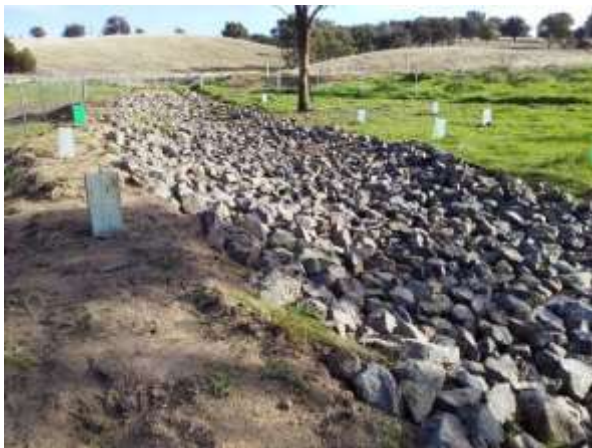
2022 fenced and planted.

2023 – thick vegetation stabilising the channel and hiding the rocks

**Jerringomar** – looking back the other way at the culvert. Hilltops Council worked collaboratively with us to extend the rock-lined channel onto their adjoining land between the culvert and the fence

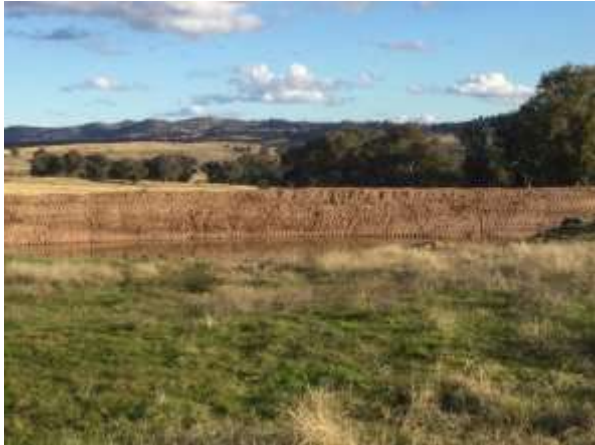
Before – (2021 after a year of rain. Normally bare and scoured). Long view and close-ups. Concentrated flow from a road culvert uphill has created this erosion gully that plunges steeply downhill in front of the eucalypt. Although normally scoured bare, the vegetation is thick here due to two rainy years

Afters – newly built dam 2022 and same dam in 2023, fenced from stock, planted and seeded and well on the way to being stabilised by vegetation

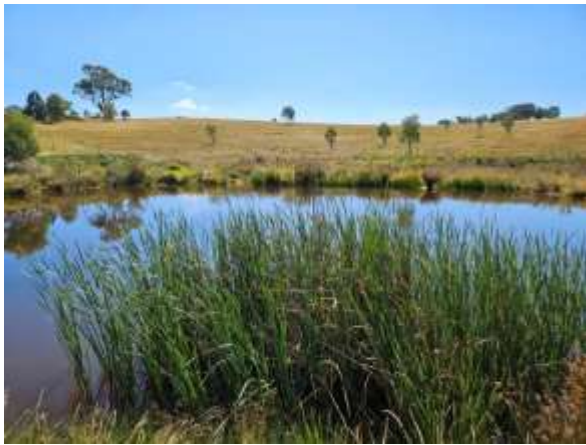
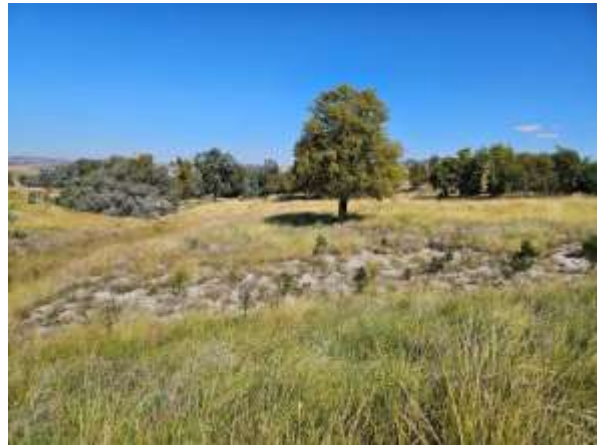
April 2024 (at 180 degrees), showing colonisation of the dam by water plants via birds, and grassing up of the banks. Second image is plantings behind the dam

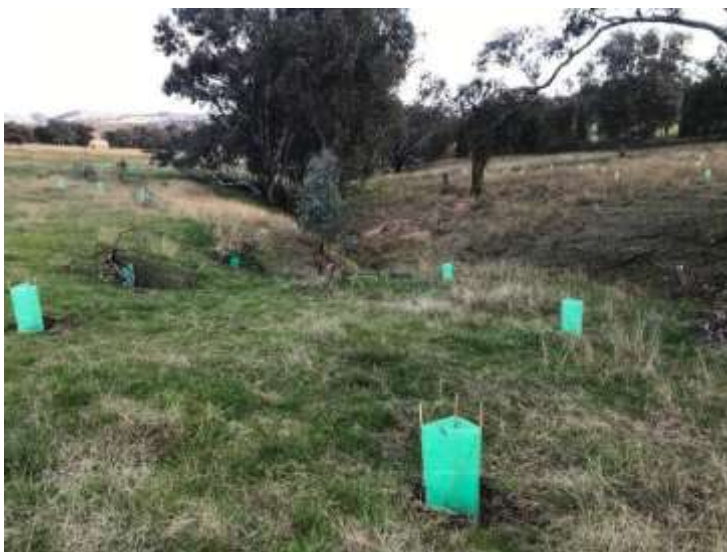
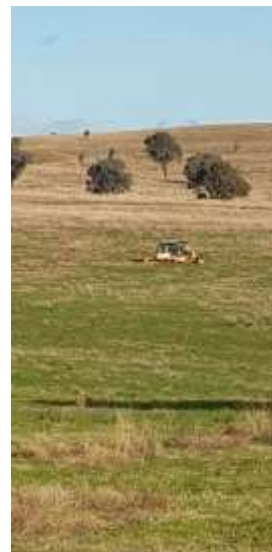
Plantings between sites 1 and 2 and excavator bogged for 18 months during 2021 and 2022

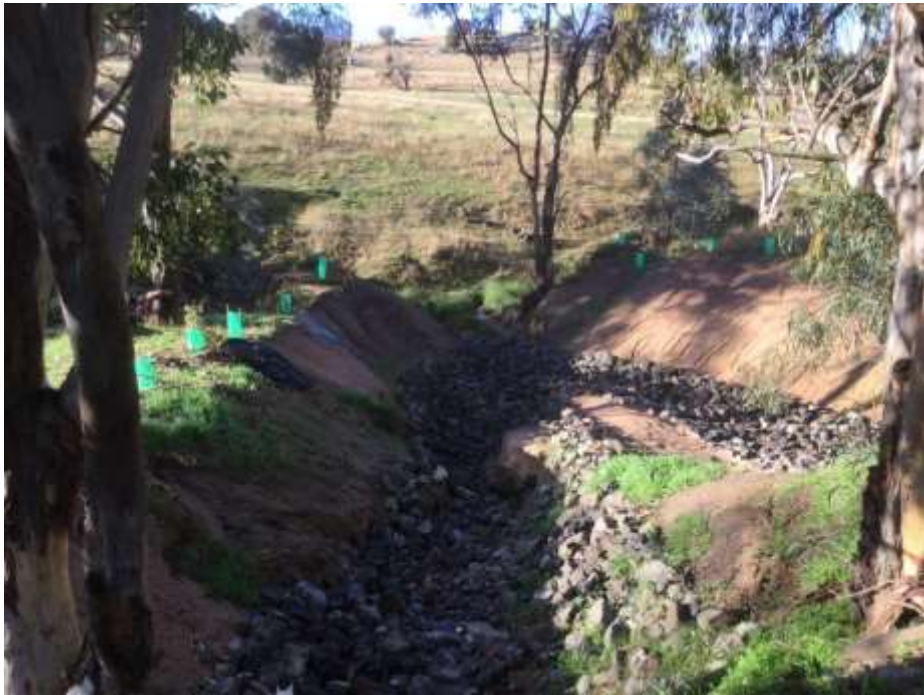
Before (2021) - This deeply gouged, very long gully is the result of decades of concentrated flow from a road culvert on the steep road above, with no structures put in place to slow the speed of the water entering the property. The culvert can be seen in the top middle of the picture just below the road.

2022 Plantings on the banks (from 180 degrees to previous photo)

After (2022) – the area where the water enters has been shaped and rocks and sandbags have been installed to slow the water. This has not repaired the long gully but will minimise further damage. The banks have been planted and the area fenced.

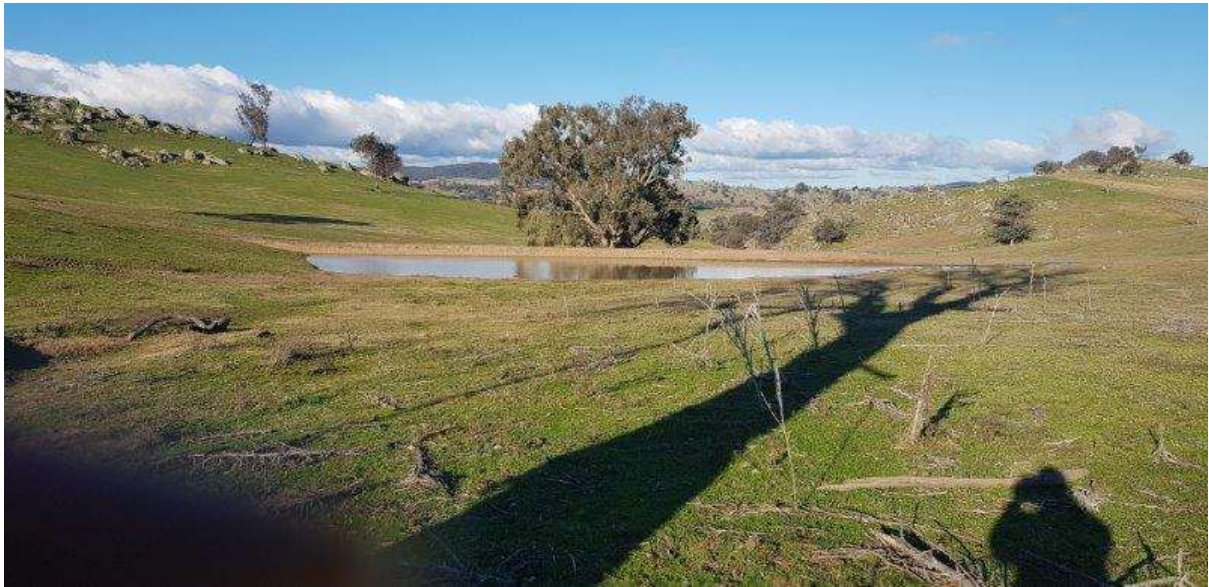
Afters (June 2022)

Before (2020) - actively eroding head and gully

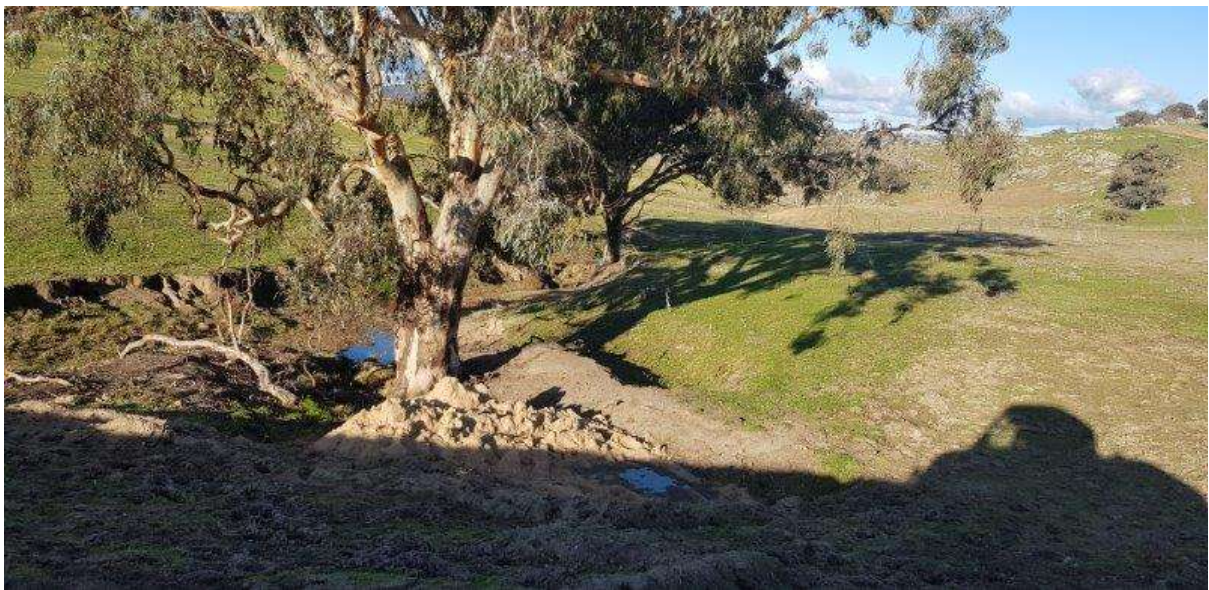
Looking down the gully from the dam wall

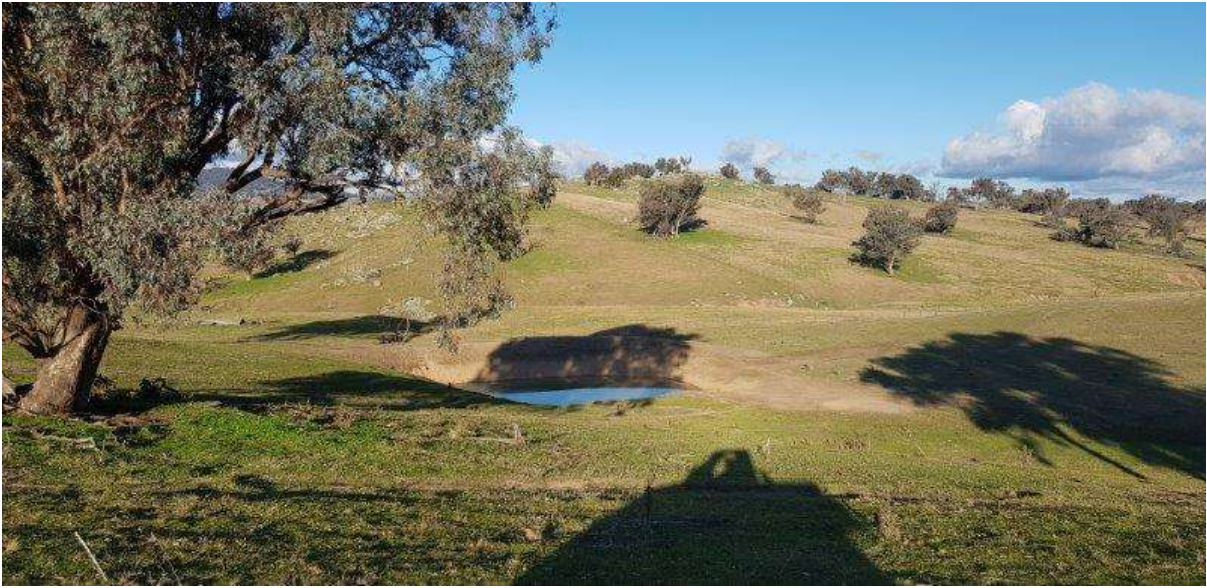
Afters (2022)

Before (2020) Actively eroding head and gully heading downhill

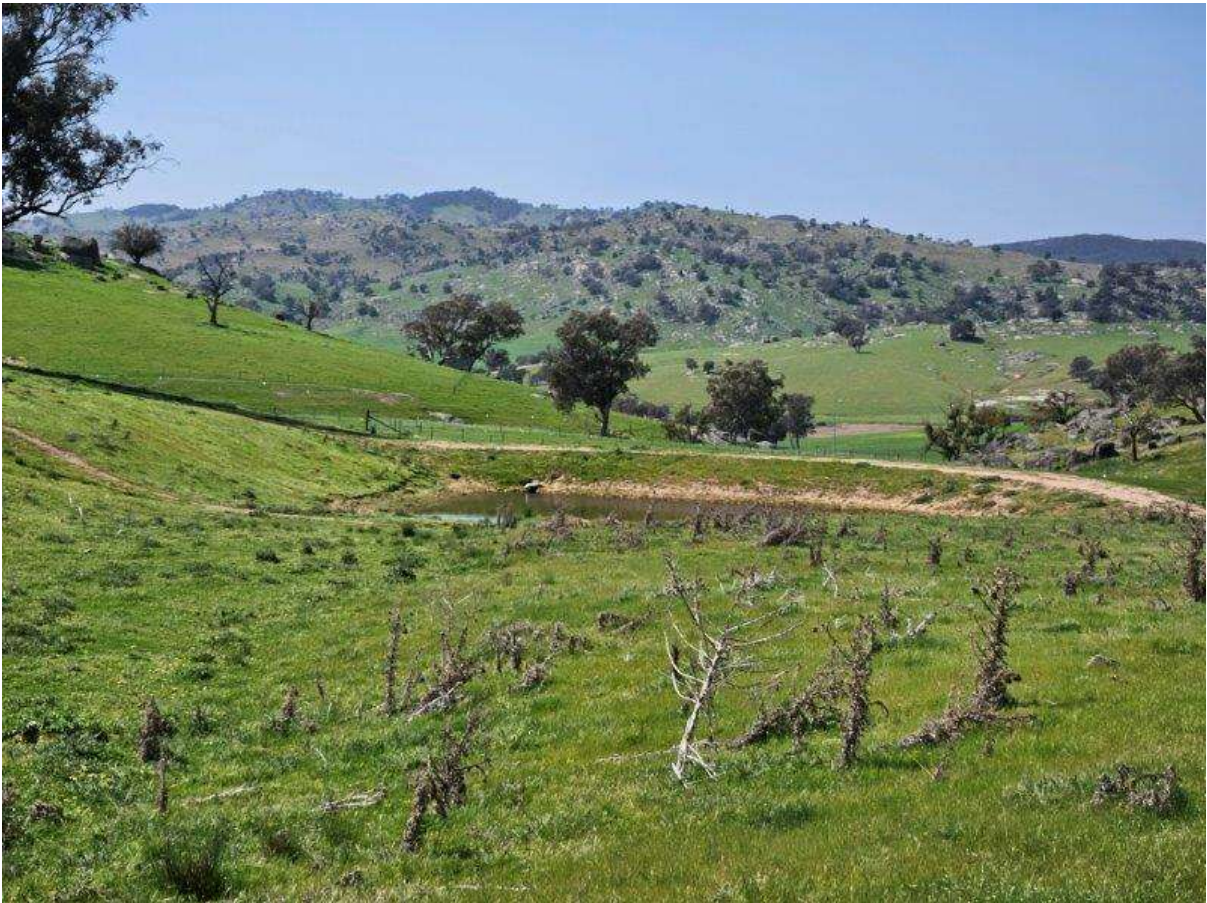
2023 (Poor angle for comparison. Original photopoints were no longer there. Should have been taken from further around to the left). Same tree on LH side.

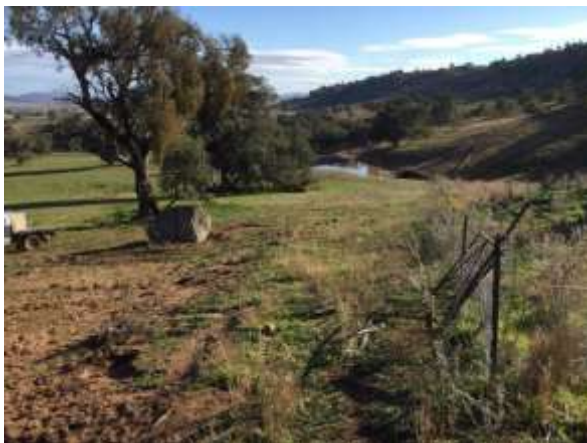
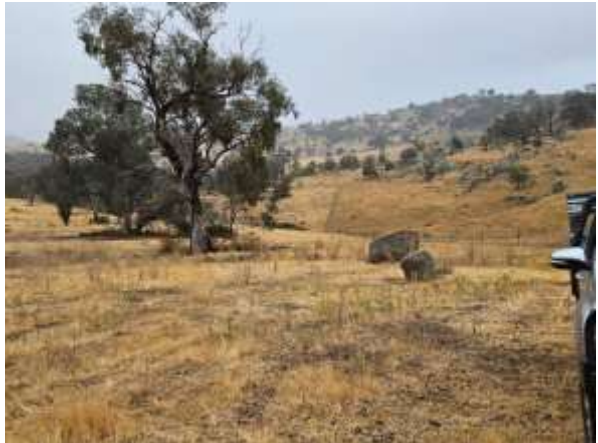
Site 1 before (2020) Gully looking downhill and looking across the top of the gully

After (2021 and 2023) – sides battered into the gully, shaped and seeded. Site 3 dam in the background.

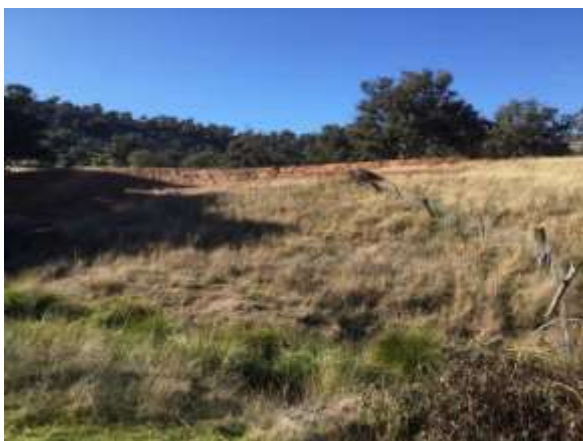
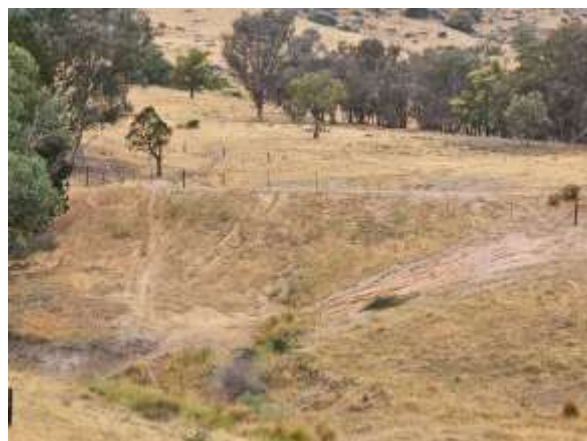
Afters (2021 and 2023)

Before (2020) Looking down the gully

Unfortunately these photos needed to be taken at right angles to the before photo, looking uphill from the photographer's shadow. This is due to a misunderstanding about the exact location of the proposed dam. They show the gully in the foreground and dam in the background. Note the fencing in the second photo.

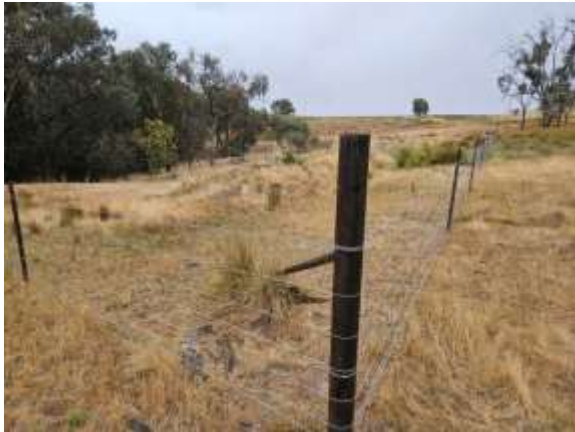
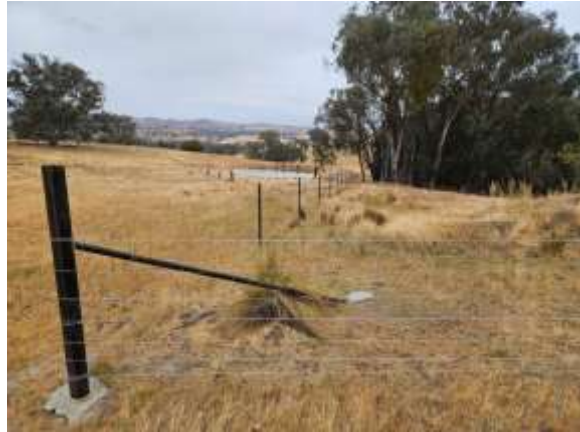
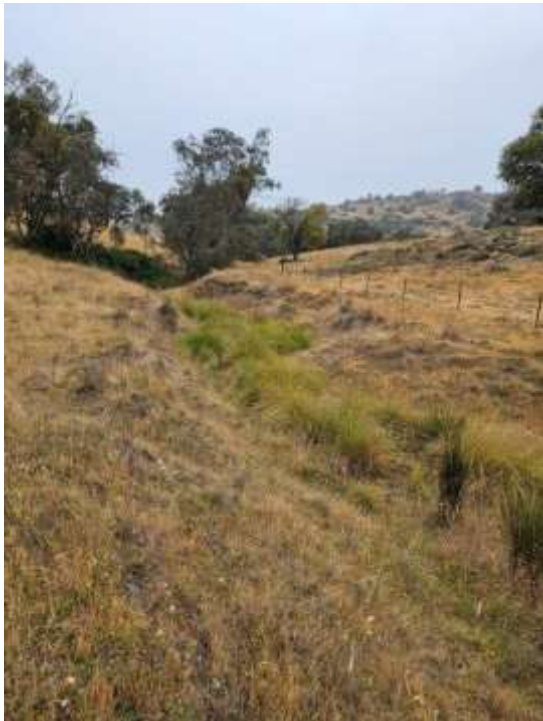
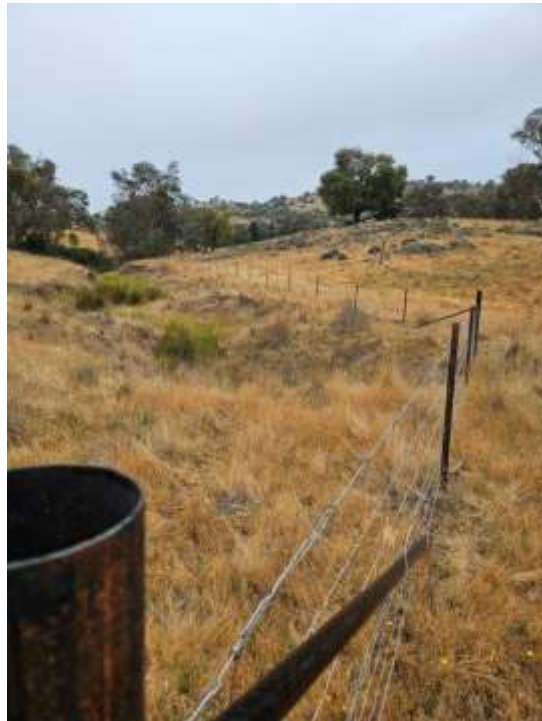
Balloch site 2 afters cont. Fencing of the gully at site 2. Dam visible in second photo.

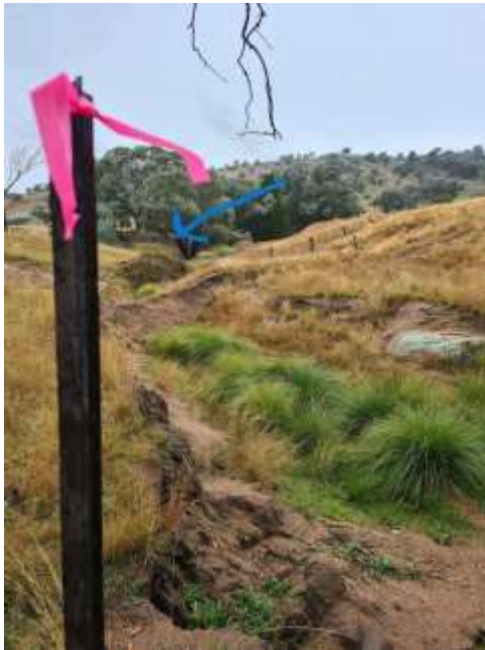
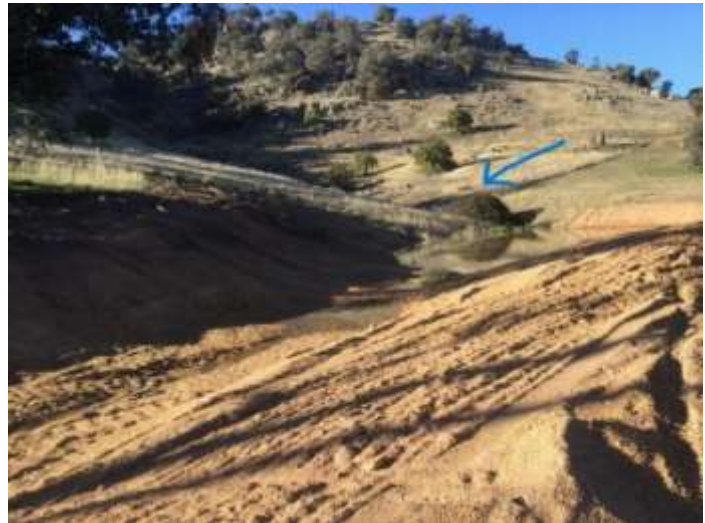
Before (2020) blue arrows show blackberry bush for reference

After (2023)

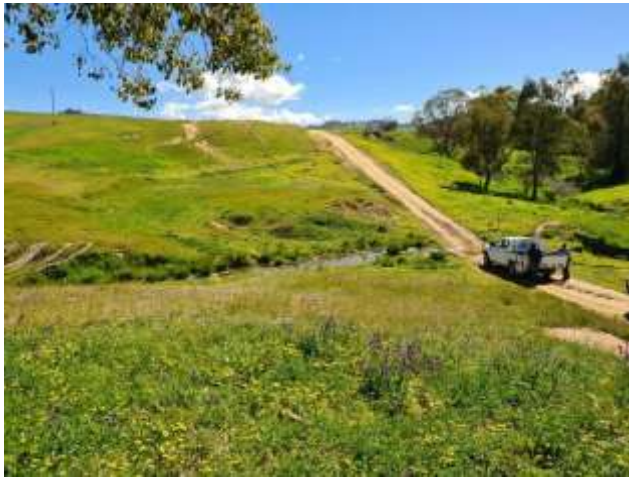
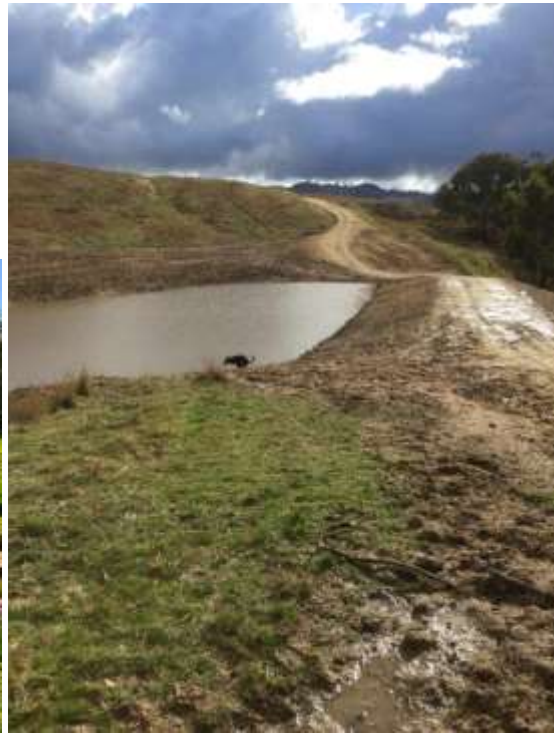
Before (2020) – water from the steep hill was cutting a deep gully downhill of the road and a section of bank was slumping.

A different view (at 90 degrees) before (2020) and after (2022)

After 2022 and 2023. The dam catches the water and releases it slowly down the gully via a trickle pipe at the bottom of the dam wall. The slumped area has been rebuilt.

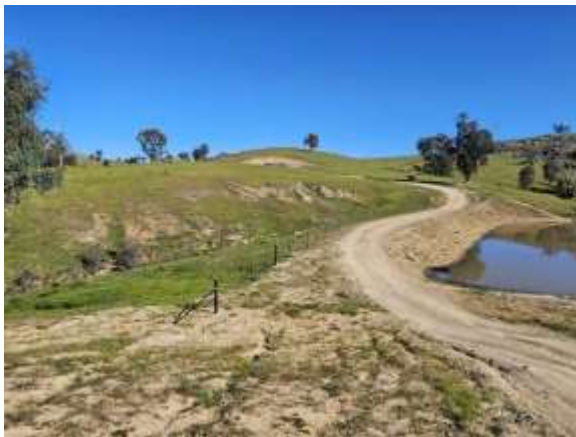
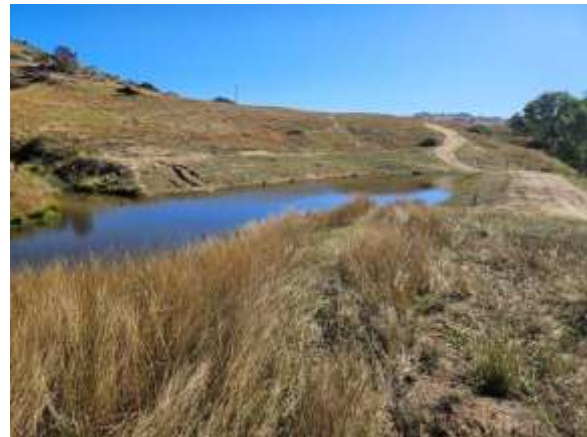
2023 (taken at 180 degrees to the image above) and 2024 The far side of the dam has also grassed up and there are water plants starting to appear courtesy of ducks.
